Defence Science and  
Technology Group

# The PC9A Filter Screening Tool

DST-Group-TR-3210

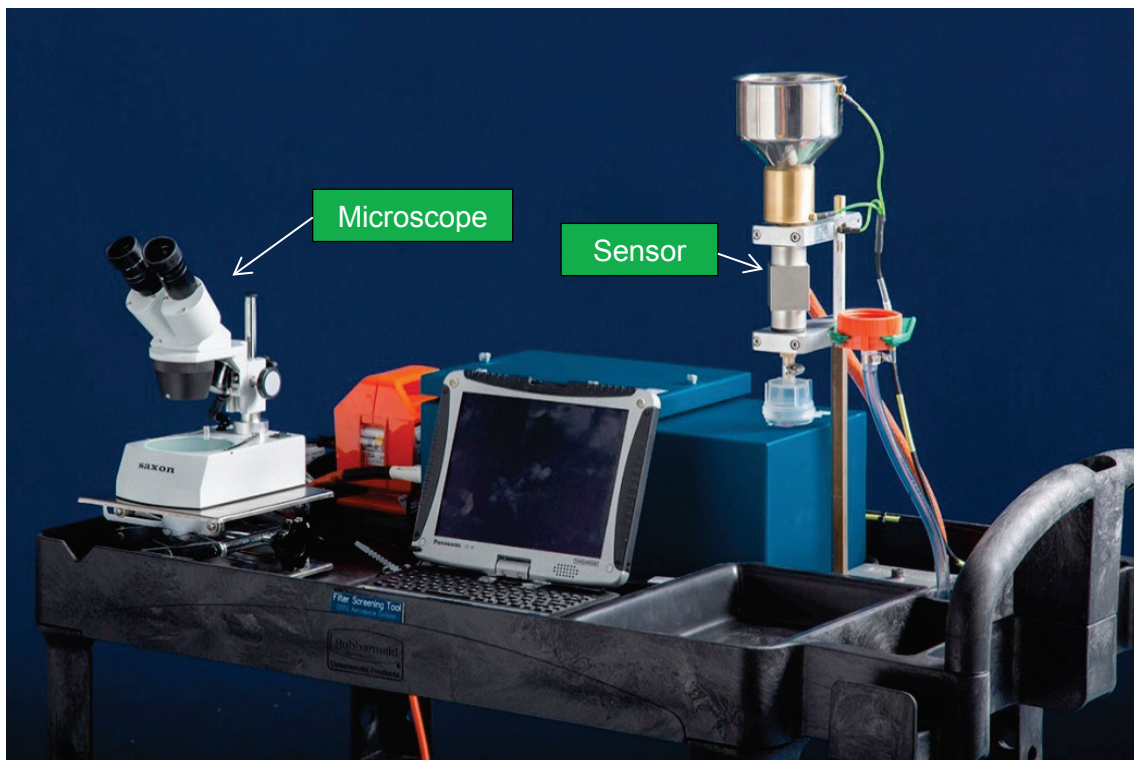
Figure 1: Overview of FST showing MetalSCAN sensor and optical microscope

The FST is a flow-through device intended to rapidly assess the debris extracted from the lubrication filter of PT6A engines. The slurry is first passed through the FST where an inductive wear debris sensor (MetalSCAN) counts, classifies and assesses the metallic particles against conservative screening limits. A filter patch fitted after the sensor then captures debris greater than 60  $\mu\text{m}$  for subsequent visual analysis using an optical microscope. The filter patch can also be sent to a laboratory for detailed analysis if any of the screening limits are exceeded. Waste solvent and finer debris passes through tubing to the waste solvent receptacle positioned in a drip tray below the device. Figure 1 shows an overview of the FST and Figure 2 contains a detailed view of the funnel, sensor and filter patch holder.

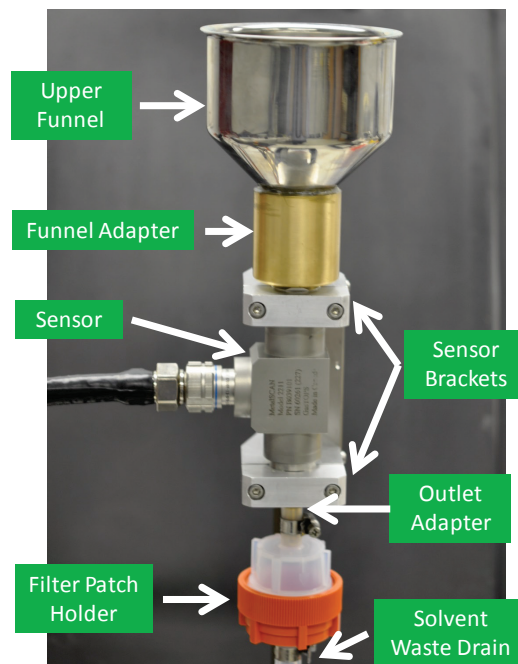
Figure 2: FST funnel, sensor and filter patch holder.

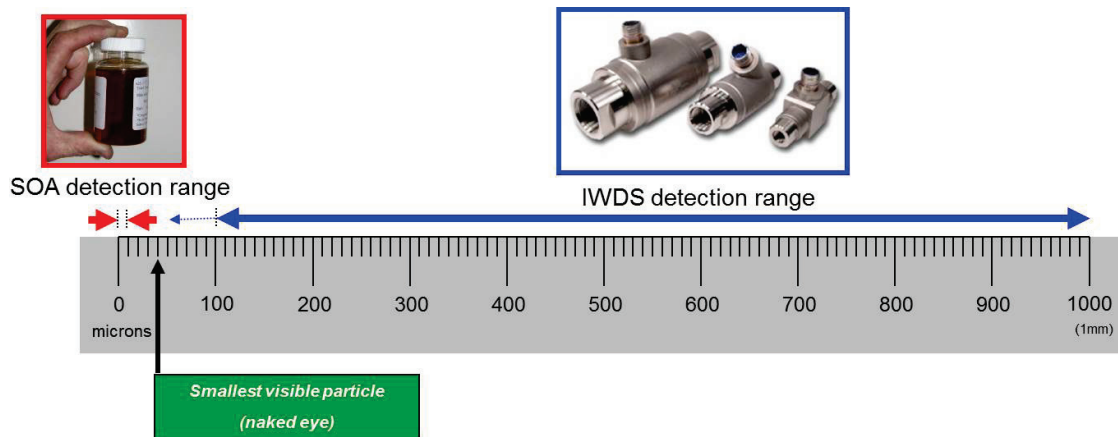
Figure 3: Comparison of traditional SOA particle detection and Inductive Wear Debris Sensor

The FST uses 3/8" MetalSCAN sensor (see Appendix A) to count, size and classify metallic particles as either ferromagnetic (Fe) or non-ferromagnetic (NFe). This sensor is an inductive sensor and can detect metallic particles over a far wider size range than conventional techniques such as spectrometric oil analysis (Figure 3). The sensor consists of three coils that surround the fluid path and detect the disruption of an induced magnetic field by metallic particles (Figure 4). The MetalSCAN sensor is a ruggedized industrial version that DST Group have used in other applications and was selected as it is the only one that has been used in aviation applications. The sensor must be connected to a Control Box via a specially shielded cable that provides a means for powering and communicating with the sensor. The Control Box is connected to a slave computer that contains the user interface software and allows changes to be uploaded to the Control Box via a RS485 connection. The computer hardware and software requirements for the MetalSCAN software are contained in Appendix B [4].

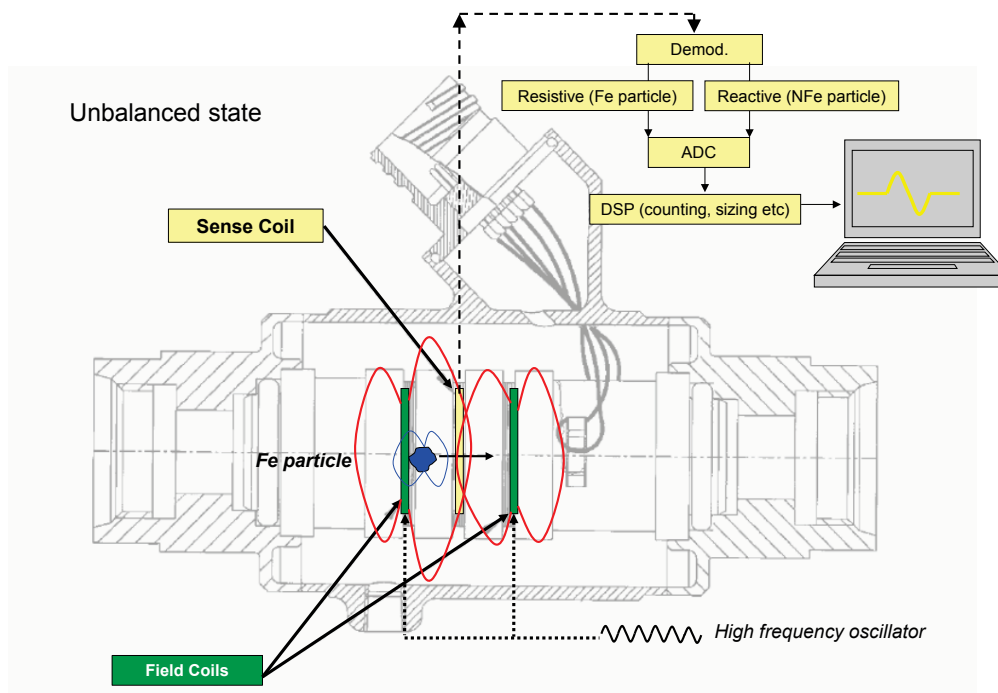
Figure 4: Cross-section of typical MetalSCAN sensor in unbalanced state showing internal field coil, sense coil and simplified signal processing block diagram

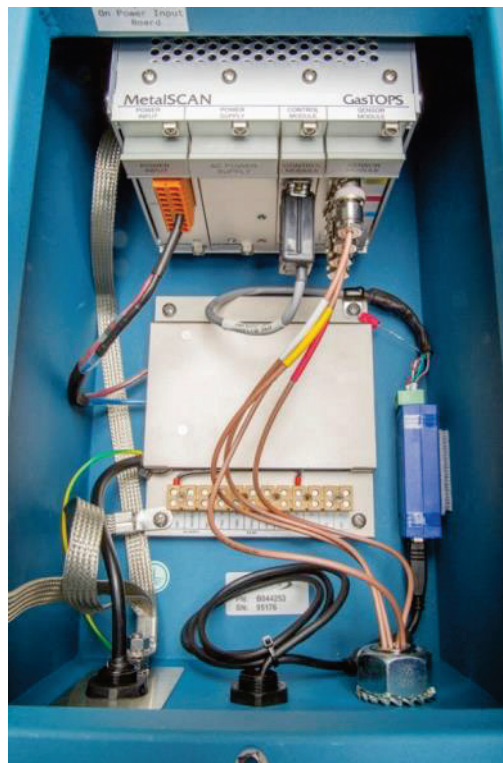
Figure 5: Interior of MetalSCAN control box showing hard-wired modifications

The MetalSCAN Control Box contains various electronic and power supply modules that enable the sensor to function, record data and communicate with the computer. In this instance a 240V version of the Control Box was used. The Control Boxes as supplied by the manufacturer do not come wired for use, therefore the DST Group engineering services contractor (Qinetiq) were engaged to wire the power cable and RS485 communication cable for both boxes. The power cable was wired in accordance with Australian Standard 3000 wiring rules [5] resulting in the exposed terminal board (provided by the manufacturer) being bypassed to reduce the number of connections and enable the power wires to be double insulated. The access fasteners provided on the Control Box are not lockable and therefore would not have met the wiring rules if the terminal block had been retained; double insulating the power cables enabled the wiring rules to be met. Figure 5 shows the internal configuration of the Control Boxes. Users of the FST are not required to access any components inside the Control Box at any time.

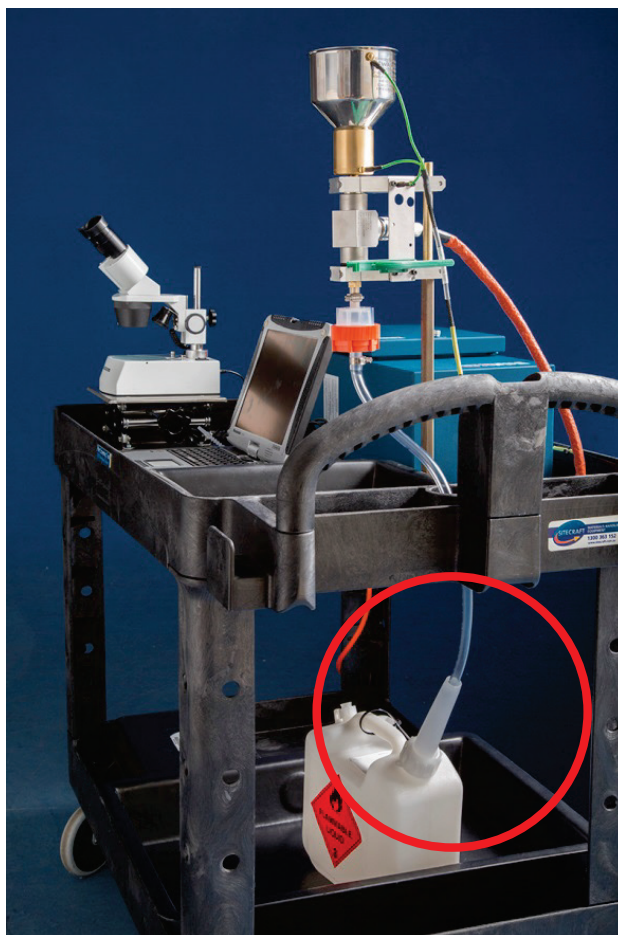
*Figure 6: FST showing location of waste solvent container and clear hose.*

The funnel is modified from a Millipore Hydrosol funnel kit and was selected due to the excellent surface finish and robust construction. The funnel is permanently adhered into a brass adapter that has been designed to precisely fit the MetalSCAN sensor entry. The outlet adapter connects the sensor to the filter patch holder where a single-use 47mm diameter filter patch with a porosity of 60  $\mu\text{m}$  is fitted for each screening. The filter patch holder is a slightly different design compared to the existing filter patch holder but performs the same function. Two 1mm diameter equalising holes exist on the upper part of the filter patch holder to assist with flow through the instrument. Clear tubing connects the filter patch holder outlet to the waste solvent container (Figure 6). The FST and waste solvent receptacle both sit in drip trays to contain any inadvertent spillage however during normal operation no spillage should occur.

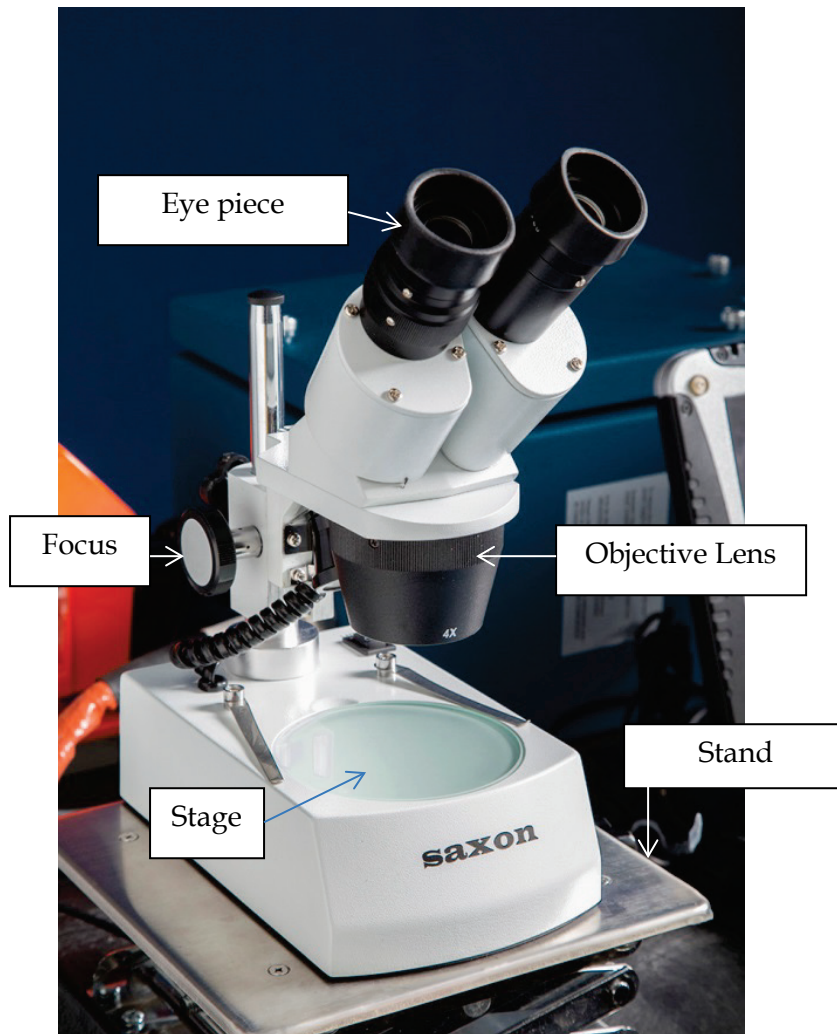
Figure 7: Saxon stereo microscope used for glass bead and bronze debris identification

The companion microscope (Figure 7) is used exclusively for visual identification of glass bead contamination and bronze-coloured debris. This microscope must be set for X4 magnification on the objective lens, which combined with the eyepiece, provides a total magnification of X40. The microscope is fixed to an adjustable stand that can be raised or lowered as desired for ease of use.

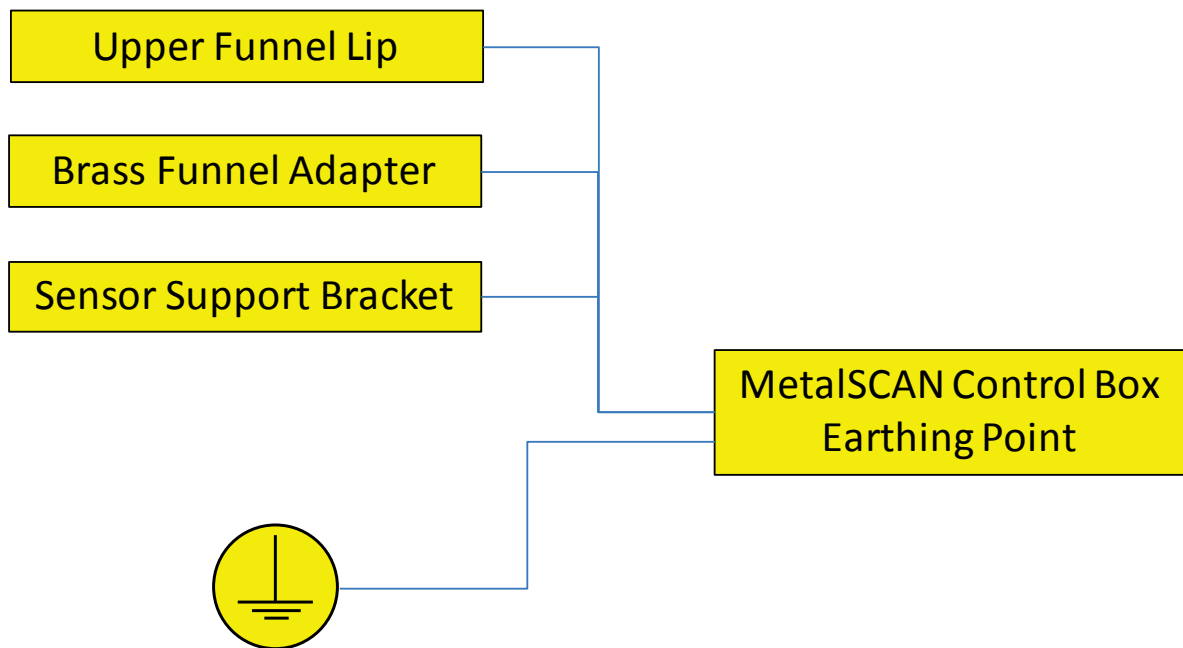
Figure 8: FST Earthing Schematic

It is essential that the FST is earthed correctly to prevent static or other electric potential differences interfering with the sensor or causing a static ignition hazard. Figure 8 shows a schematic of the system earthing configuration and Figure 9 shows the earthing leads attached to the various sub-components of the funnel assembly. Figure 10 shows the earthing connection on the MetalSCAN Control Box and shows that all funnel items are earthed to the Control Box which is in turn earthed to the power supply outlet earth. Users are instructed to visually check the earthing leads prior to each use and an annual continuity check is mandated (Section 6.2). The FST must not be used if the earthing leads are damaged or disconnected.

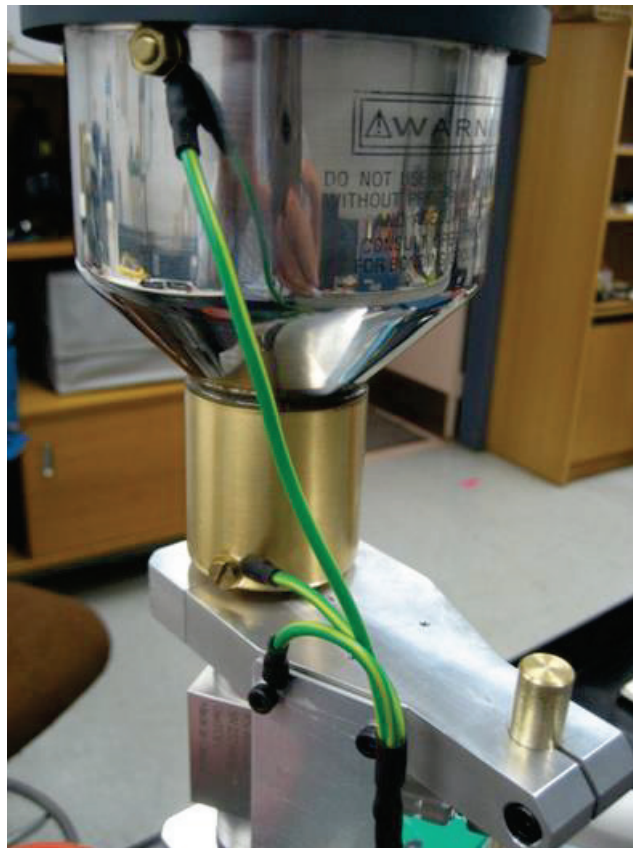
Figure 9: Anti-static earthing leads on funnel adapter and sensor bracket

Step	Action	Comment
Prepare	1 Earth	Visually check the earthing leads are connected at the funnel and the MetalSCAN control box (see Figures 9 and 10).
	2 Power on, computer on, software start	Turn the power on to FST then start the computer. Start the MetalSCAN Monitor software by double-clicking the icon.
	3 Insert new filter patch and connect	It is essential that a new filter patch be inserted at the commencement of each screening. Failure to insert the filter patch will result in loss of debris. After inserting a new filter patch connect the lower filter patch holder to the upper filter patch holder.
	4 Quick test sensor	Pass the black test straw down through the sensor and then back out. Two Fe Counts should appear on the <b>Status</b> screen.
	5 Clear Counts	<p>The MetalSCAN software must be manually cleared to ensure only the counts from the current screening are recorded. To clear counts:</p> <ol style="list-style-type: none"> <li>1. From the main <b>Status</b> screen Select the <b>Counts</b> button from the main toolbar (Figure 11)</li> <li>2. In the <b>Counts</b> screen click on the <b>Clear Counts</b> button in the lower right corner of the screen (Figure 12). A <b>Clear Particle Count Data</b> prompt will appear (Figure 13). Click <b>OK</b>.</li> <li>3. A password prompt will appear. Type <b>MAINT</b> (case sensitive) followed by <b>Enter</b> to clear the counts (Figure 14).</li> <li>4. Return to the <b>Status</b> screen.</li> <li>5. The bottom right corner of the screen should show the word <b>LOGGING</b> in a green background when the instrument is communicating correctly with the sensor (Figure 11).</li> </ol>

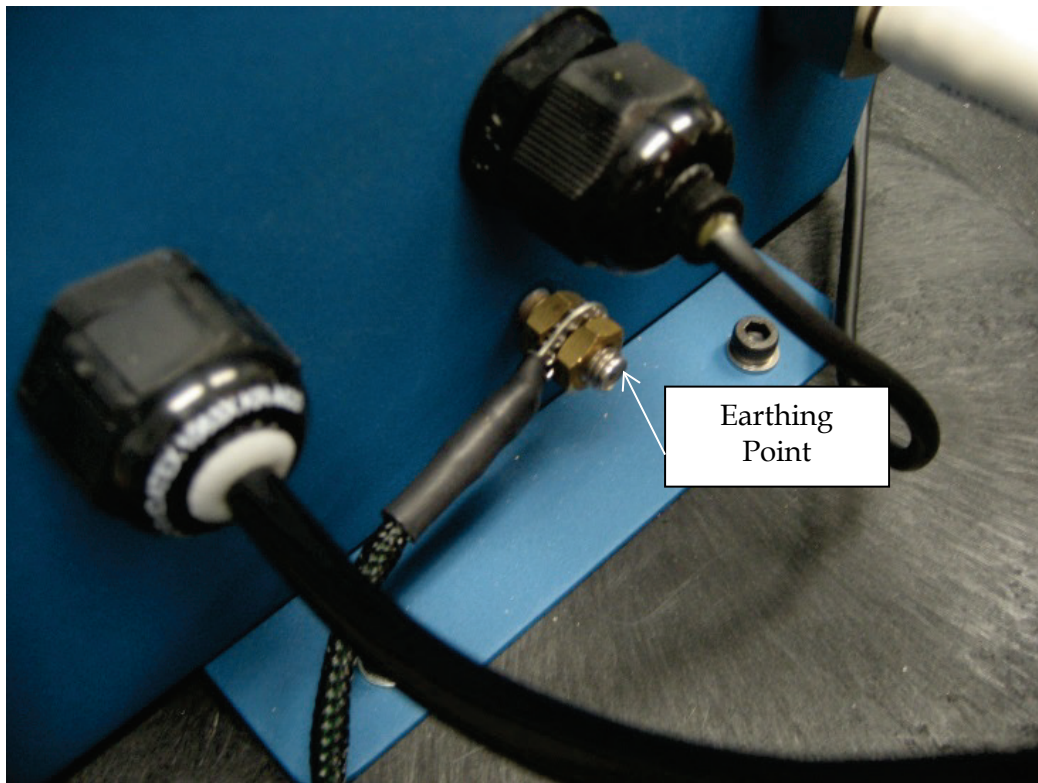
*Figure 10: Earthing point on MetalSCAN control box*

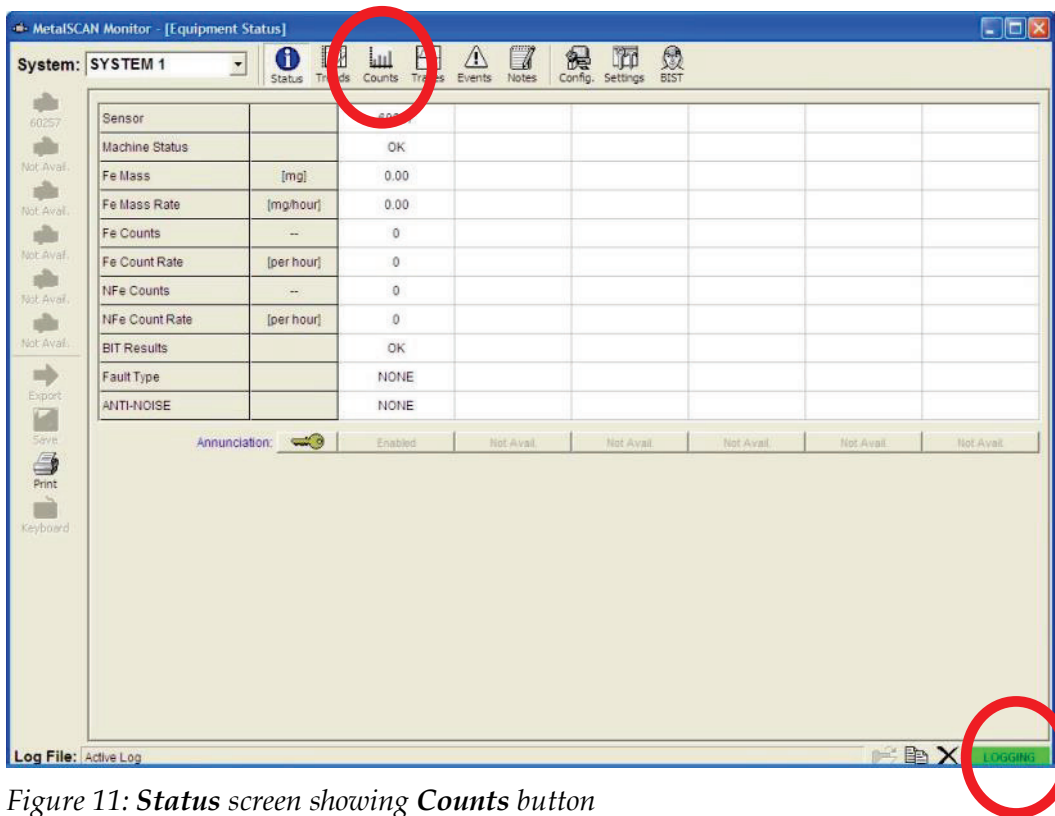
Figure 11: Status screen showing Counts button

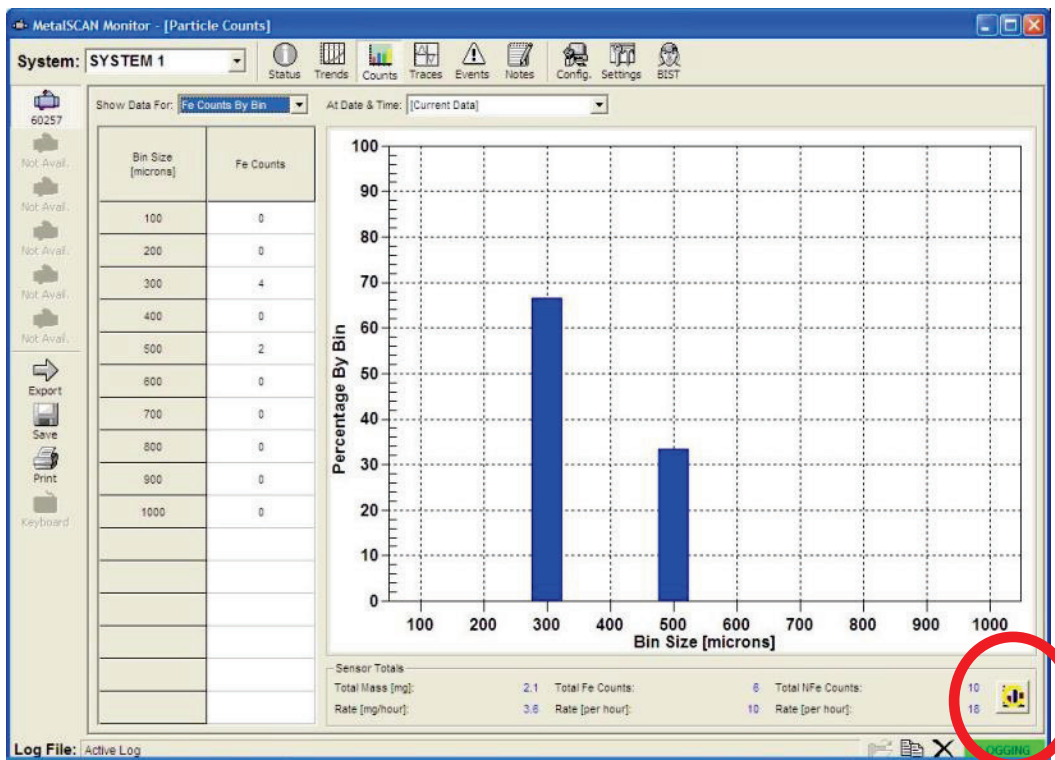
Figure 12: Counts screen showing clear counts button

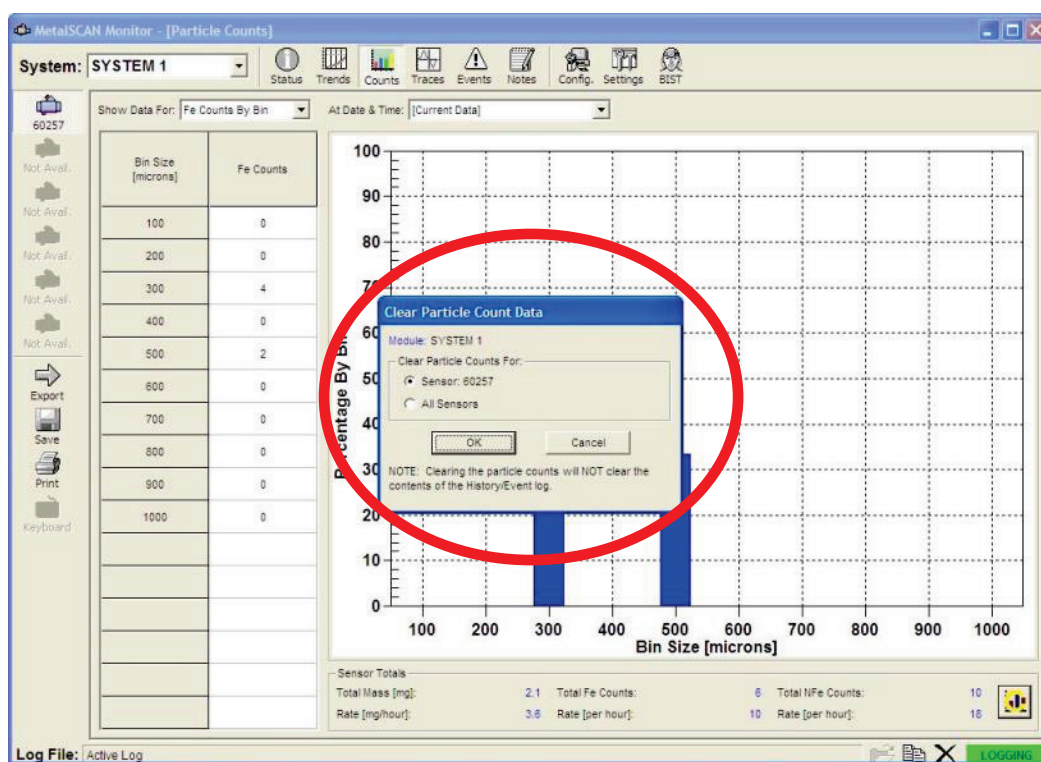
Figure 13: Counts screen showing prompt after clicking clear counts button

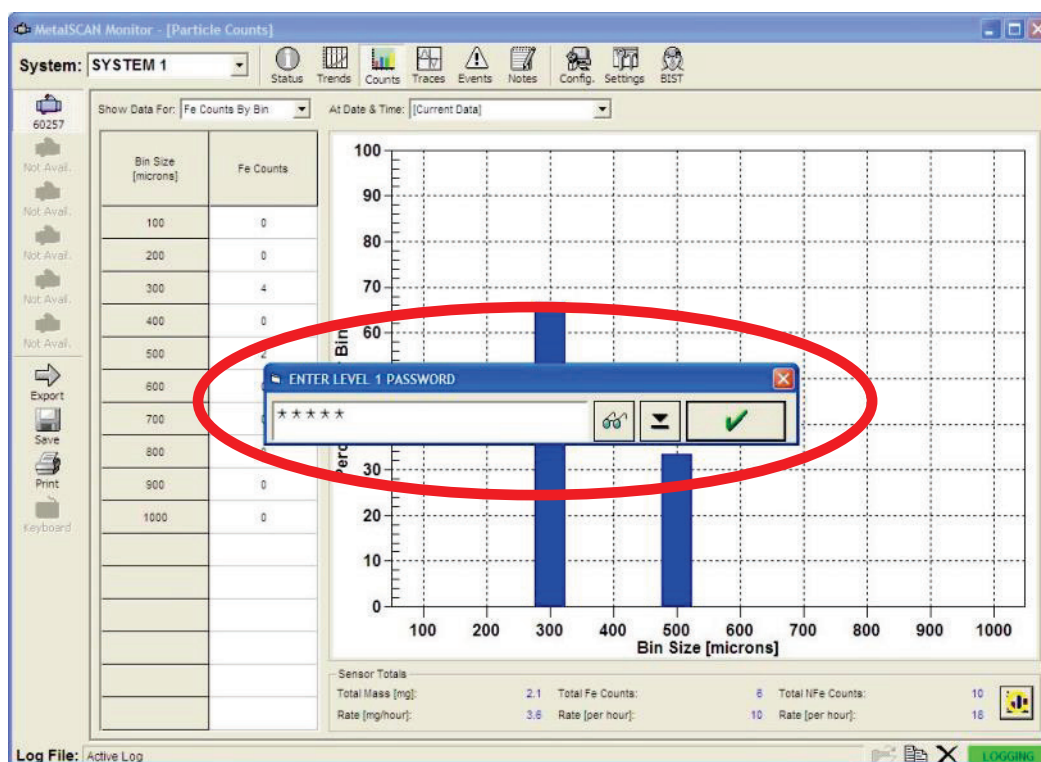
Figure 14: Counts screen showing password prompt. Password must be typed in to clear counts

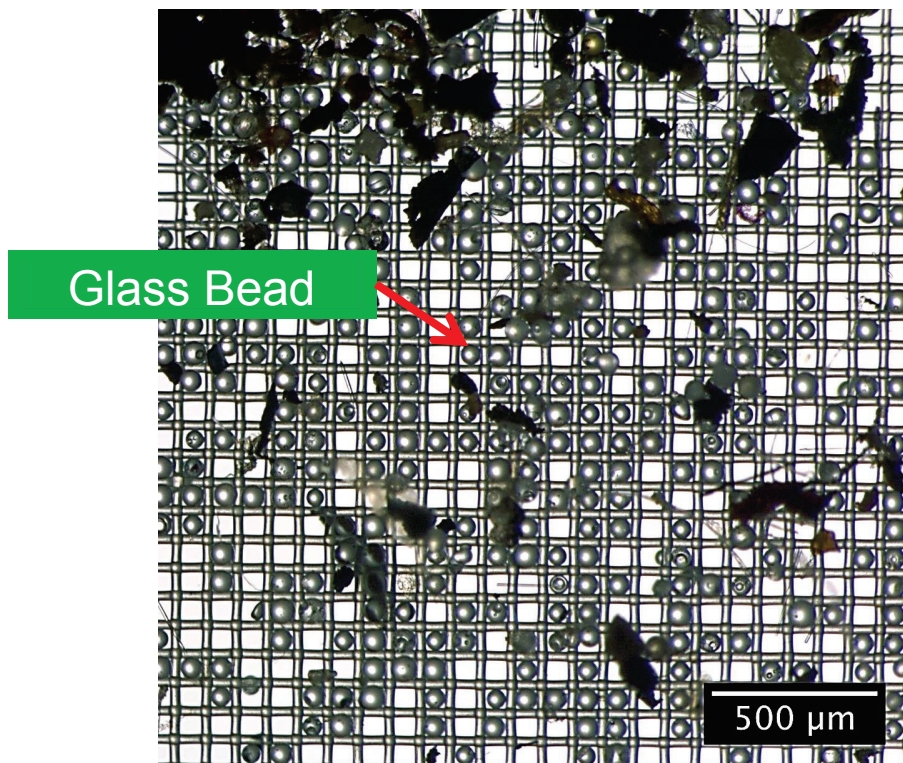
Figure 15: PC-9/A filter patch view at x40 magnification (back lit) showing extreme glass bead contamination

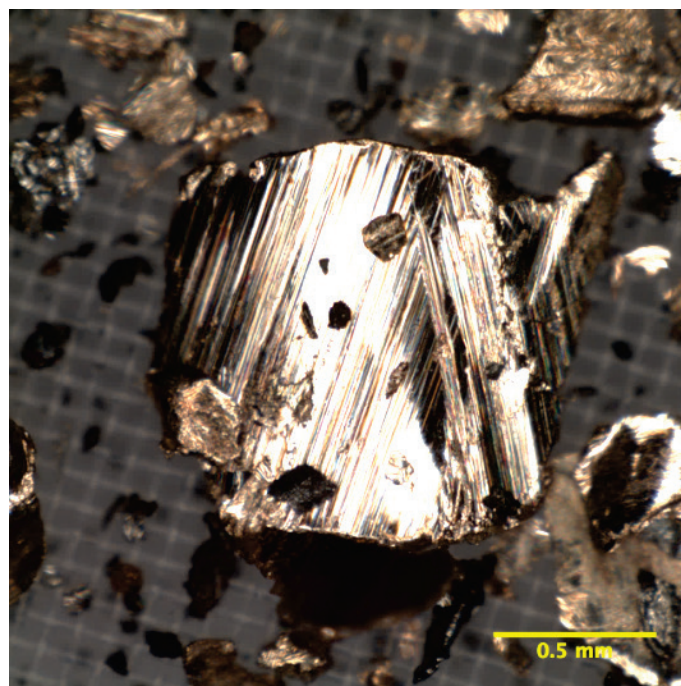
Figure 16: Example of bronze-coloured debris - in this case the debris was found to come from the bronze journal bearings

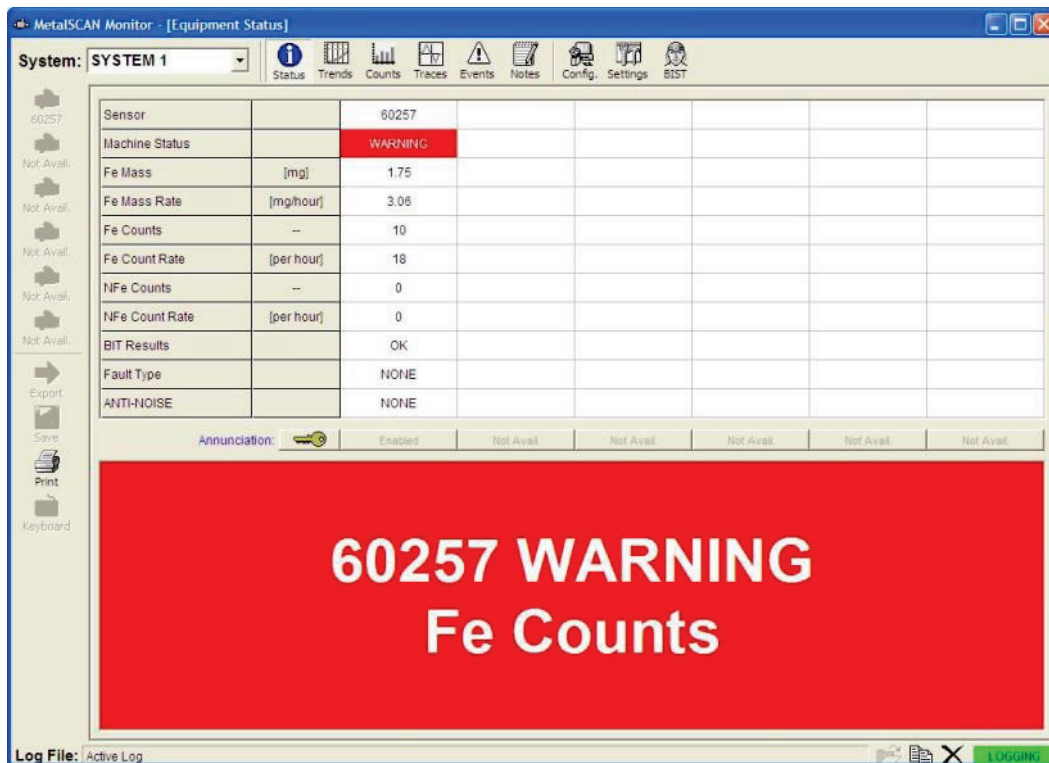
Figure 17: MetalSCAN Monitor software showing ferromagnetic (Fe) particle count limit exceedance warning

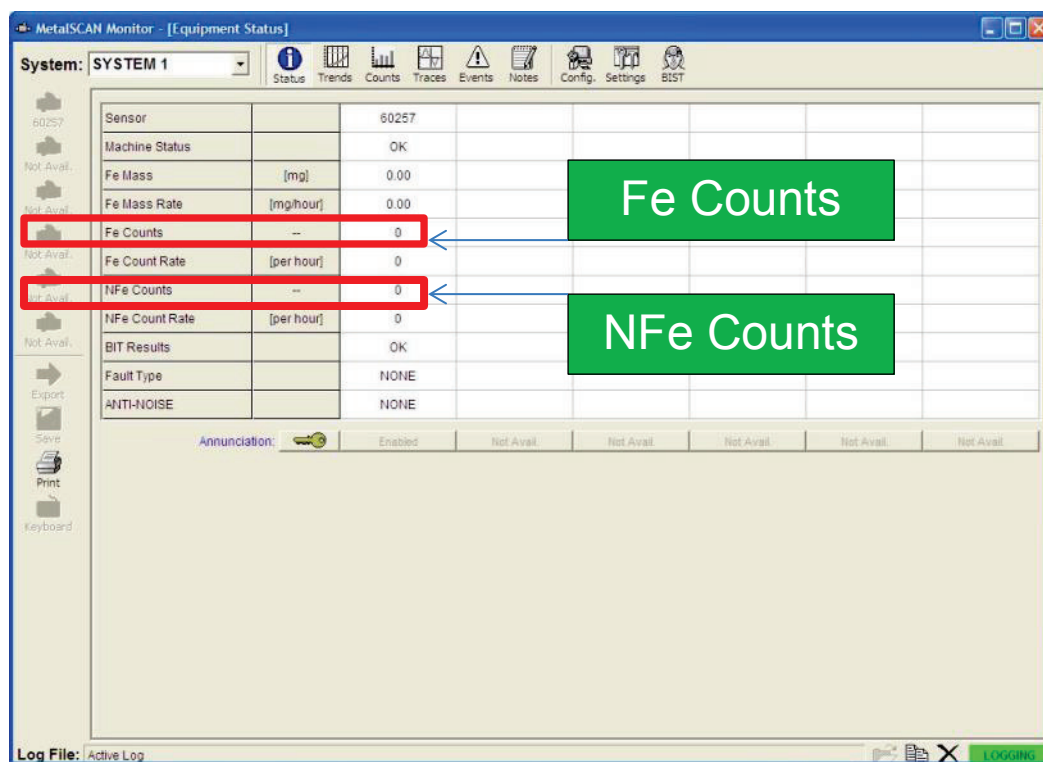
Figure 18: Status screen showing where Fe and NFe Counts are recorded

Results for the ferromagnetic (Fe) count and non-ferromagnetic (NFe) count are obtained from the *Status* screen of the MetalSCAN software (Figure 18). The Fe rate and NFe rate values are meaningless in this application and should be ignored; they are intended to be used where the sensor is installed in a machine lubrication system and measuring continuously. It is recommended that a form like that shown in Appendix F be used to record each screening.

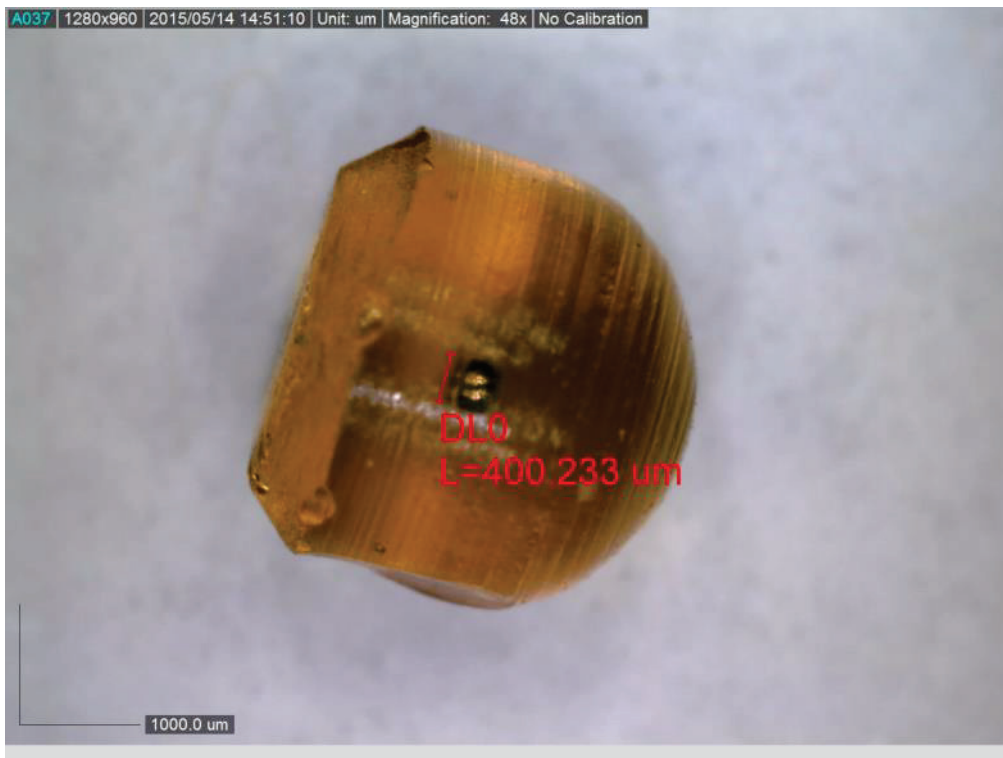
Figure 20: 400  $\mu\text{m}$  spherical Fe particle encapsulated in resin and used for FST testing

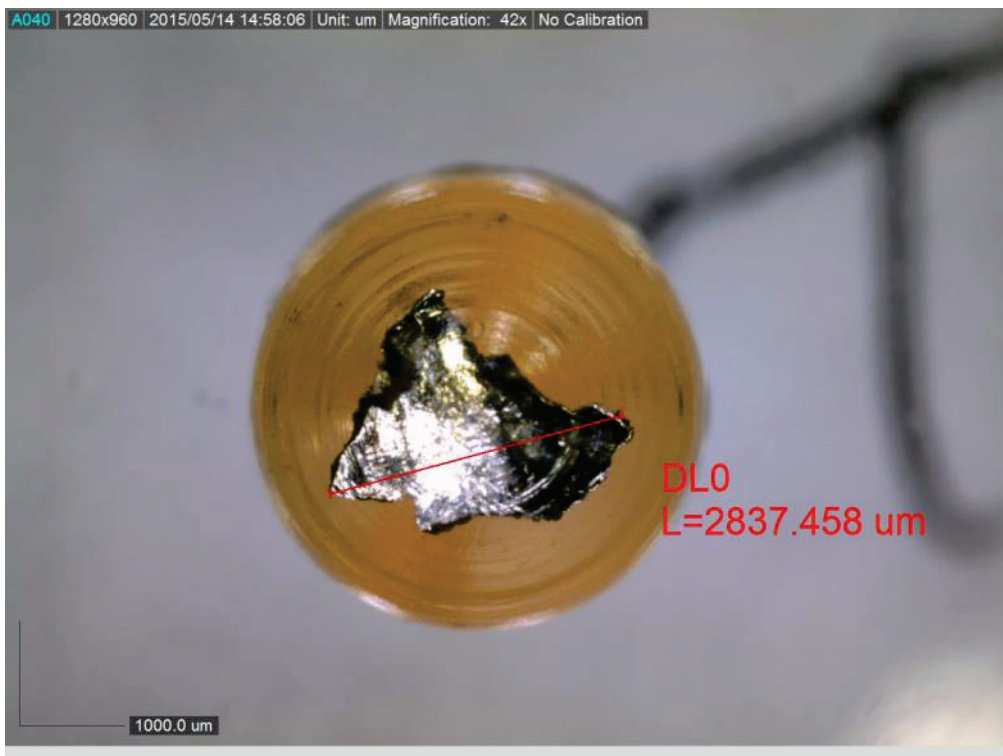
Figure 21: Flake X (real Fe wear debris) encapsulated in resin and used for FST testing

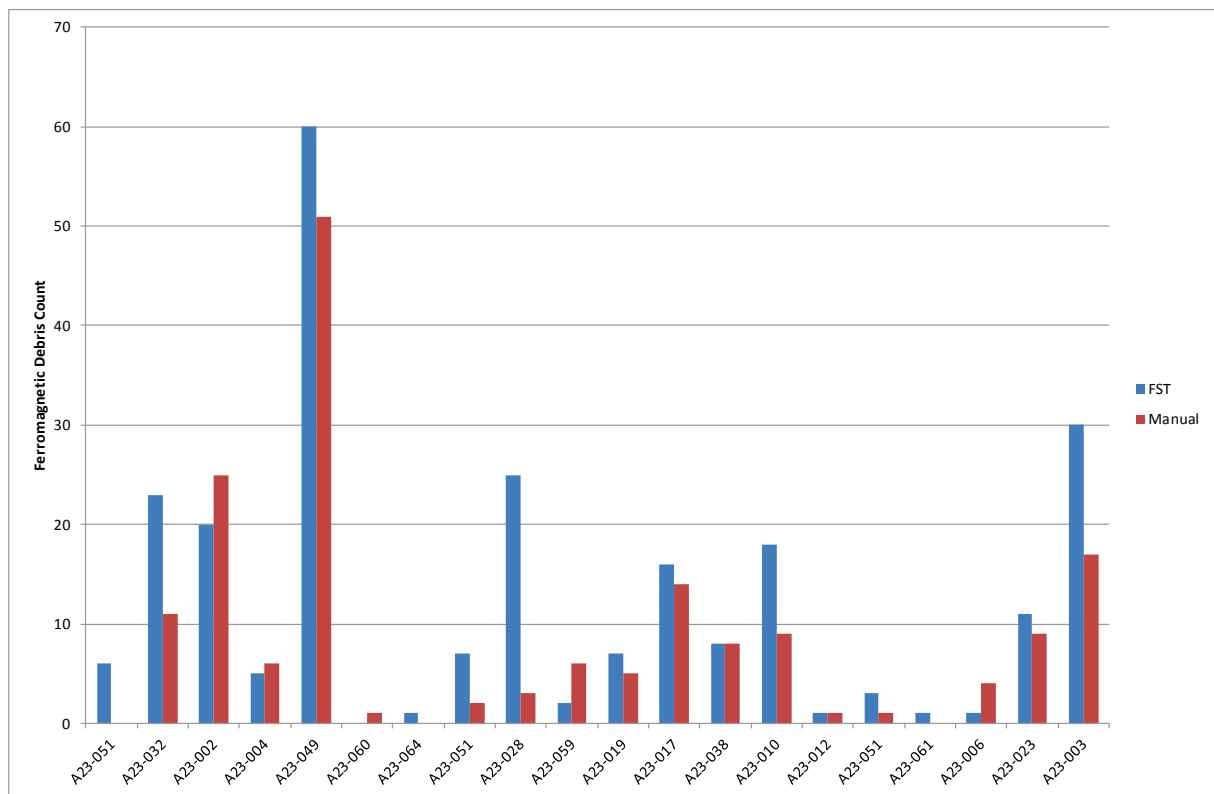
Figure 22: Comparison of manual analysis (red) with FST analysis (blue) detection of ferromagnetic debris

According to the PWC wear debris guidance, Fe debris (e.g. steels) are the predominant cause of non-allowable debris. This is intuitive since most gears and bearings are made of alloy steels. For this type of debris the FST generally identified more debris than the manual process. This is not surprising since the minimum detection threshold for the FST is set at 120  $\mu\text{m}$  whereas the manual analysis does not consider particles below 250  $\mu\text{m}$ . The FST settings can be readily adjusted to align with the manual analysis threshold if required in the future.

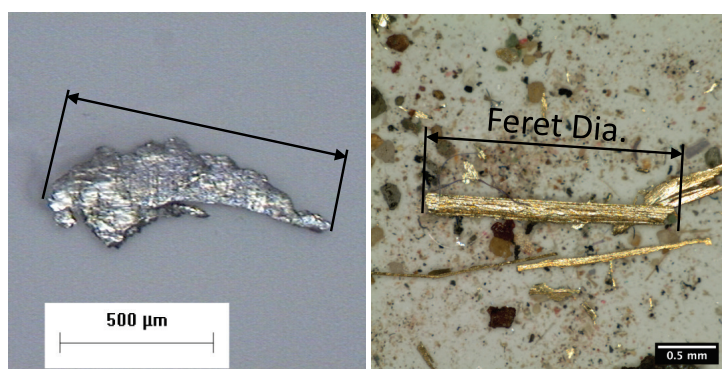
Figure 23: Comparison of how a Feret (calliper) dimension can artificially classify a strand as a large particle. The mass of the strand (right image) would be significantly less than the flake (left image) and therefore not necessarily be detected by the MetalSCAN sensor. Note: These examples are not from PT6A engines.

In each of the three cases listed in Table 12, a significant portion of the manually detected debris was in the form of long thin strands. When measuring manually, the analyst measures the longest dimension (known as the Feret or calliper dimension) and this is the dimension given to the particle. A strand manually measured and a strand measured by MetalSCAN will not produce the same dimension (Figure 23). The MetalSCAN detects Fe particles based on the mass of the particle and to some extent its orientation relative to the sensor so it is reasonable to conclude that the mass of a long thin strand falls below the detection threshold.

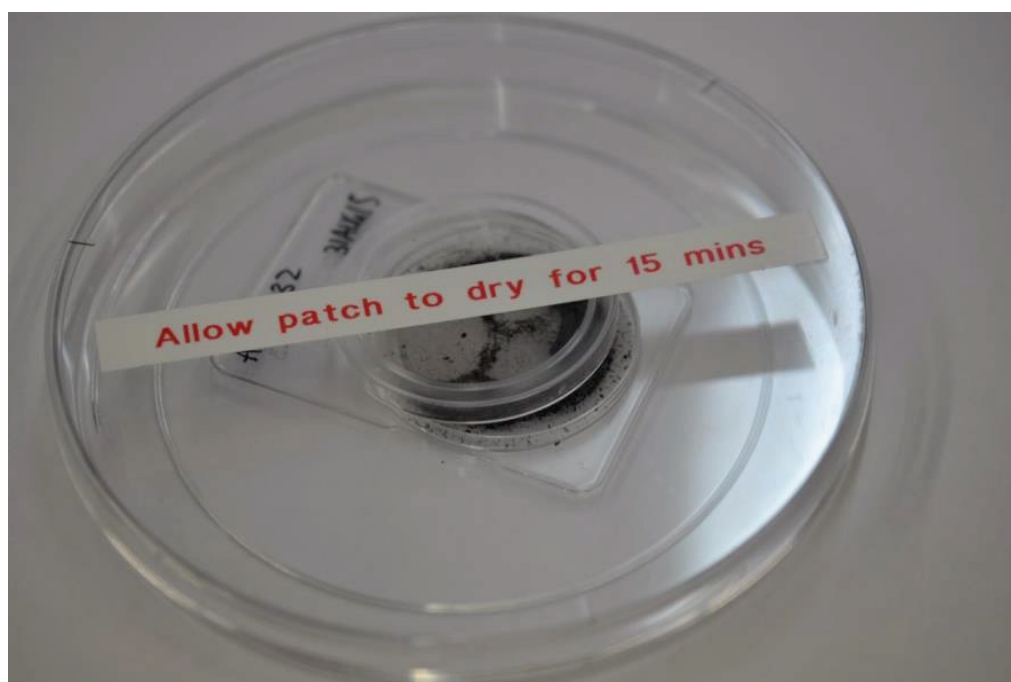
Figure 24: Drying dish with filter patch and petri dish inside

There were no instances where glass bead contamination was missed by the FST process. Initially there was some concern from Airflite staff that four of the filter patches had been identified with glass beads using the FST process but were then reported as containing none following manual analysis. Further investigation revealed that mis-interpretation could occur if the filter patch was not fully dried before conducting the optical microscopy check. At a certain stage of the filter patch drying process, the residual IPA wicks into the 60 µm pores of the filter patch and can appear similar to glass beads under transmitted light (i.e. transparent and roughly spherical in shape). As a result of this investigation a minimum drying time of 15 minutes was implemented to ensure the IPA has completely dried before optical assessment is commenced. Figure 24 shows how the filter patches are dried in a larger petri-dish to prevent contamination from external sources.

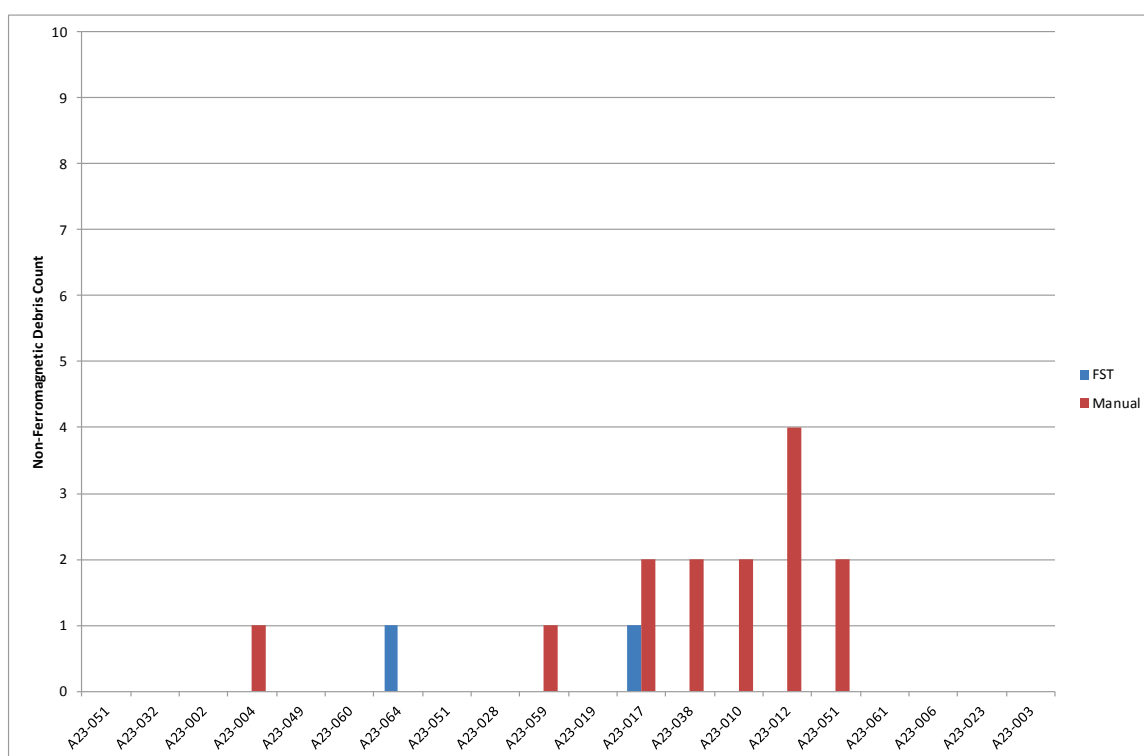
Figure 25: Comparison of Manual (red) and FST (blue) detection of non-ferromagnetic debris

Very little NFe debris was reported from either method during the validation process and the debris that was identified did not correlate well (Figure 25). The detection of NFe debris is known to be more difficult than Fe debris detection using the MetalSCAN sensor primarily due to the variability in conductivity between various NFe metals. With the exception of bronze (discussed previously), NFe debris is classified as “allowable” [6] for the PT6A engine and therefore was not considered essential for the screening process. Whilst the detection of general NFe debris was considered to be inadequate for this application, DST Group will investigate whether further enhancement of the NFe detection is possible.

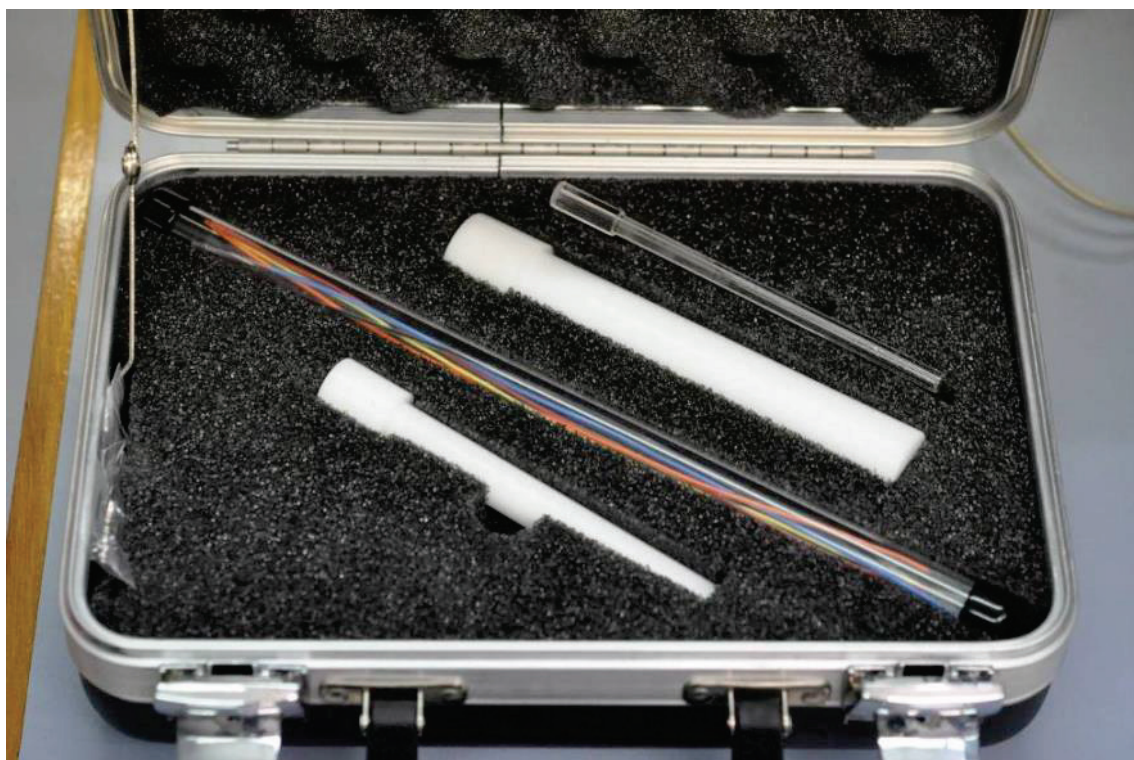
Figure 26: MetalSCAN performance test kit

No routine calibration is recommended by the sensor manufacturer. Instead, a performance test kit (Figure 26) is provided containing particles of known size encased in thin plastic straws that can be easily passed through the sensor. The test kit consists of 5 test straws each containing a single particle of known size (Figure 27). Table 13 contains the particle size and type for each coloured test straw. Whilst the kit contains a mix of Fe

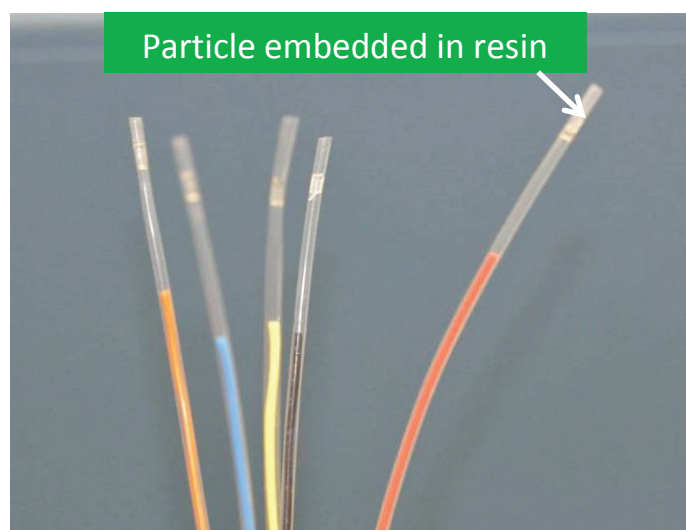
Figure 27: MetalSCAN performance test straws. Each coloured straw contains a particle of known size.

Straw colour	Particle size ( $\mu\text{m}$ )	Particle type
Red	762	Fe
Yellow	505	Fe
Black	305	Fe
Orange	904	NFe
Blue	706	NFe

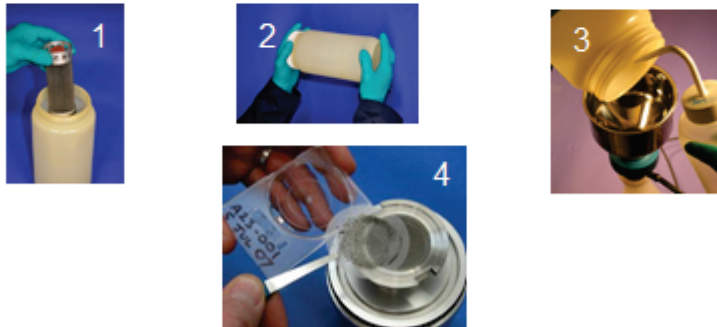
### Background - what are filter patches?

- One-use 47 mm dia piece of filter material (nylon)
- Captures particulate >60 micron extracted from scavenge oil filter
- Advantage: captures all debris >60 micron for analysis.
- Disadvantage: difficult to analyse.

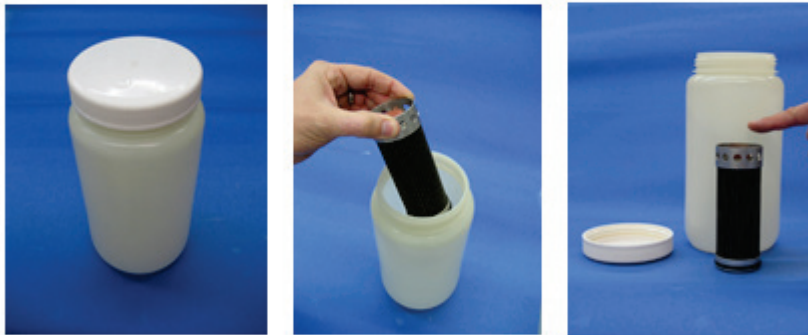
### Background – what's changed?

- Extracting the debris from the filter has not changed
- Analysing the slurry has – no longer just make a filter patch
- Screen the slurry in the field then decide if it requires a full analysis

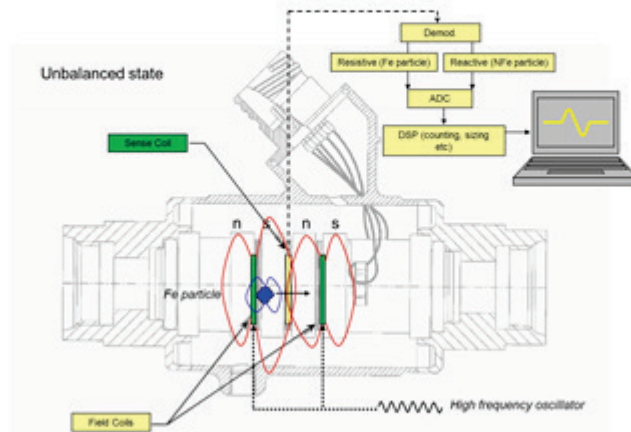
At the heart of the FST is an inductive sensor. Here's how it works:

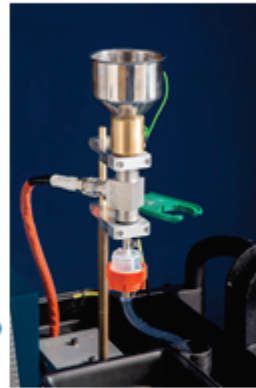
## FST Operation – Sequence Overview

1. Prepare
  - a) Check Earthing
  - b) Power On/Computer On/MetalSCAN On
  - c) Insert New Filter Patch & Connect
  - d) Quick Test Sensor
  - e) Clear Counts
  - f) Check Waste Solvent Hose Inserted & Container empty
2. Screen
  - a) Pour Slurry & Rinse Funnel
  - b) Record Fe and NFe Counts
  - c) Transfer Filter Patch to Petri Dish (allow 15 minutes to dry)
  - d) Microscope Check of Patch
    - Glass Bead (switch position I – bottom lit)
    - Bronze Debris (switch position II – top lit)
3. Secure
  - a) Clean Funnel & replace dust cap
  - b) Empty Waste Solvent Container
  - c) Clear Counts
  - d) Software OFF/ Computer OFF/ Power OFF
  - e) Cover microscope
